Manhole Inspection Summary

Manhole # S19EE2004MH

Insp Date: **9/19/06 3:55 PM**

Location Address: **5701 NEWBERRY ST**

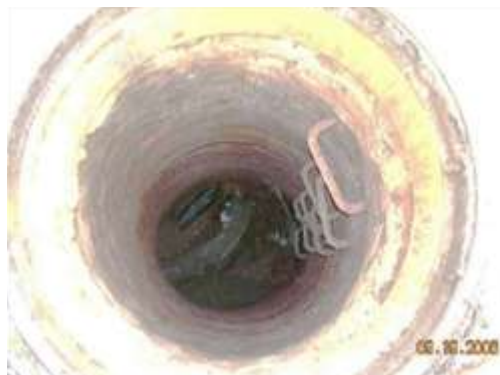
Top View

Adjustment deterioration and infiltration. Frame offset. Corroded steps. Evidence of surcharge - Bench debris.

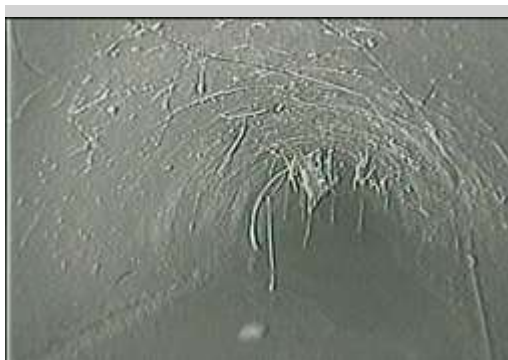
Inside the I8

Root intrusion inside of the I8 pipe.

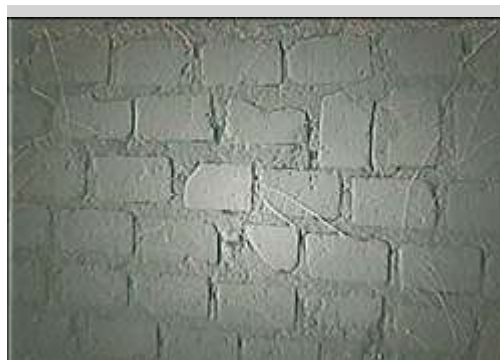
Defect

Barrel root intrusion and infiltration.

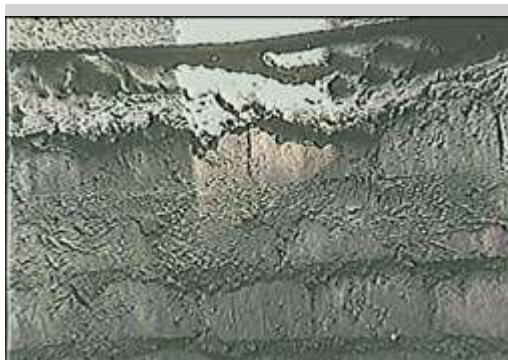
Defect

Frame leaks. Adjustment and Corbel infiltration.

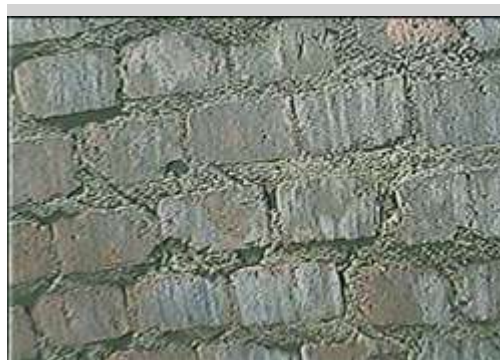
Defect

Corbel infiltration.

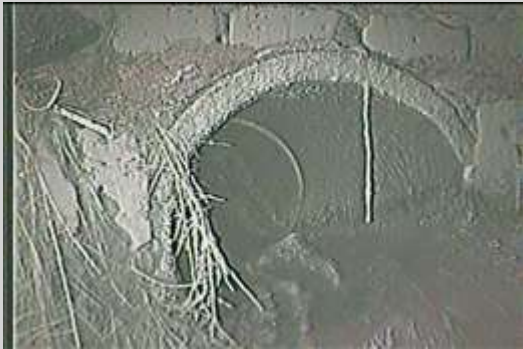
10 in. Circular Gravity Sewer Pipe Out @ 12 O'Clock

Infiltration: **Evidence** Pipe Seal Cond: **Roots**

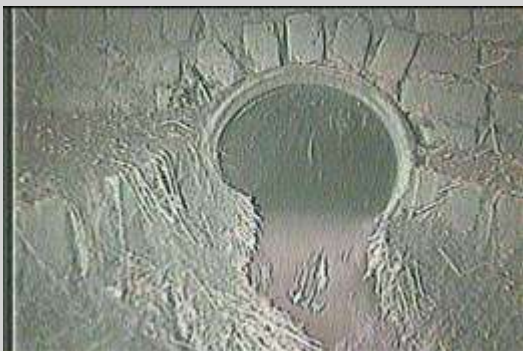
10 in. Circular Gravity Sewer Pipe In @ 8 O'Clock

Barrel deterioration, root intrusion and infiltration. Bench and Channel root intrusion.

Infiltration: **None** Pipe Seal Cond: **Roots**
